Brick Paving Systems in Expeditionary Environments: Field Testing

Haley P. Bell and Quint Mason

July 2012

Final report

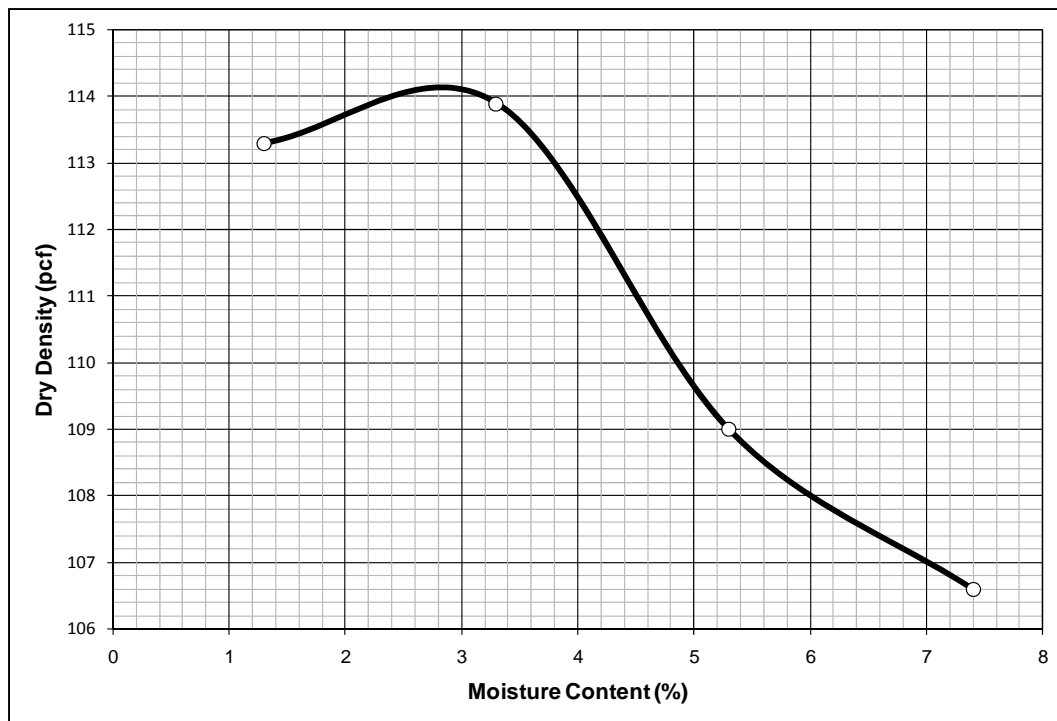
Figure 5. Dry density versus moisture content for blended GM base course.

Laboratory results indicate that the GM blend has an estimated specific gravity of 2.7, optimum moisture content of 2.6 percent, and a maximum dry density of 114.2 pcf. Figure 5 shows the Proctor curve developed by the MTC for the GM blend. The MTC followed ASTM D 698-07 Method C (ASTM 2007b) and ASTM D 1883-07 specifications for the testing (ASTM 2007a).

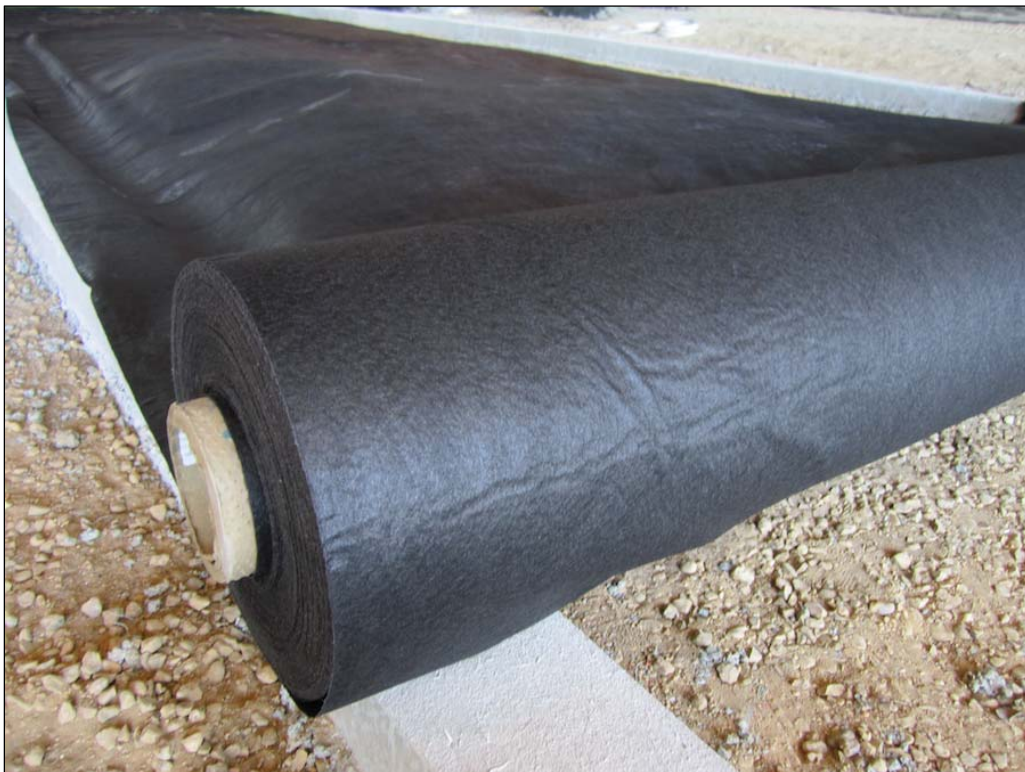
Figure 6. Geotextile material used for supporting bedding sand.

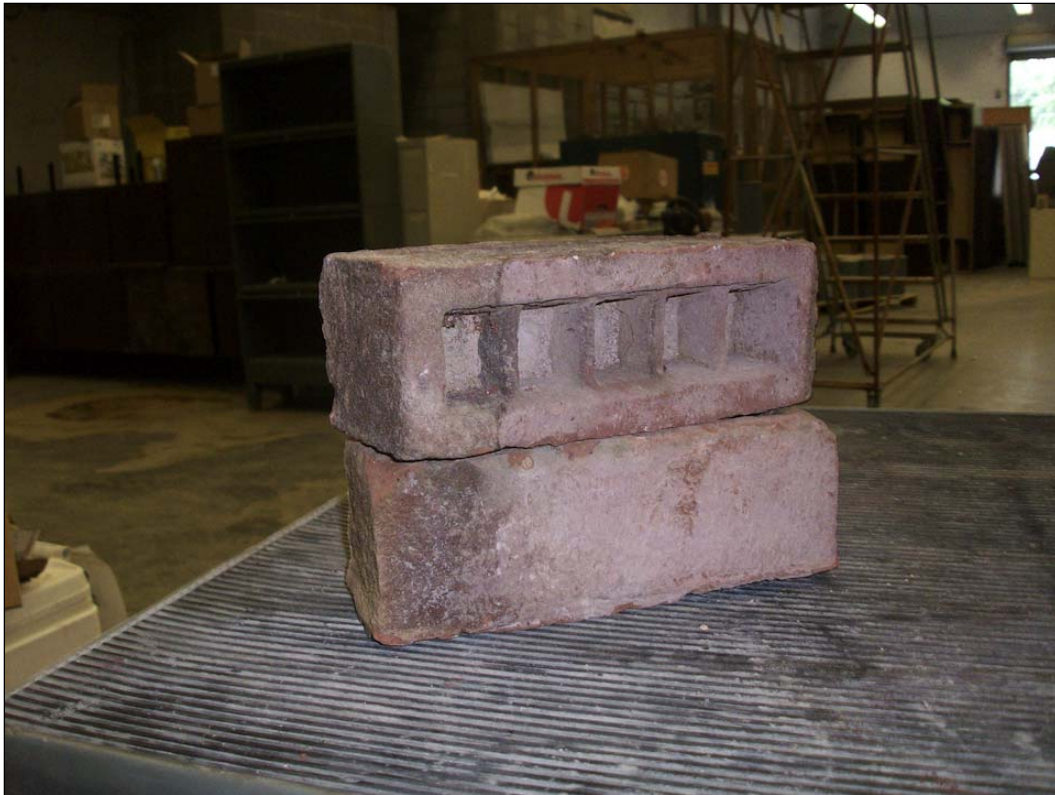
Figure 7. Queen brick.

The brick distributor noted that the queen bricks are most likely what is used in areas such as Afghanistan. This was confirmed with employees of the U.S. Army Corps of Engineers, Afghanistan Engineer District (Reed Freeman, e-mail and telephone interviews, November 5, 2010; Gregory Hales, e-mail interview, November 9 and 10, 2010; John P. Heard, e-mail interview, November 8, 2010). These particular bricks were cast in a wood mold and fired in a kiln. This type of process and brick appearance likely are indicative of the type of bricks used in more primitive parts of the world. Figure 7 shows the queen brick used in the test section.

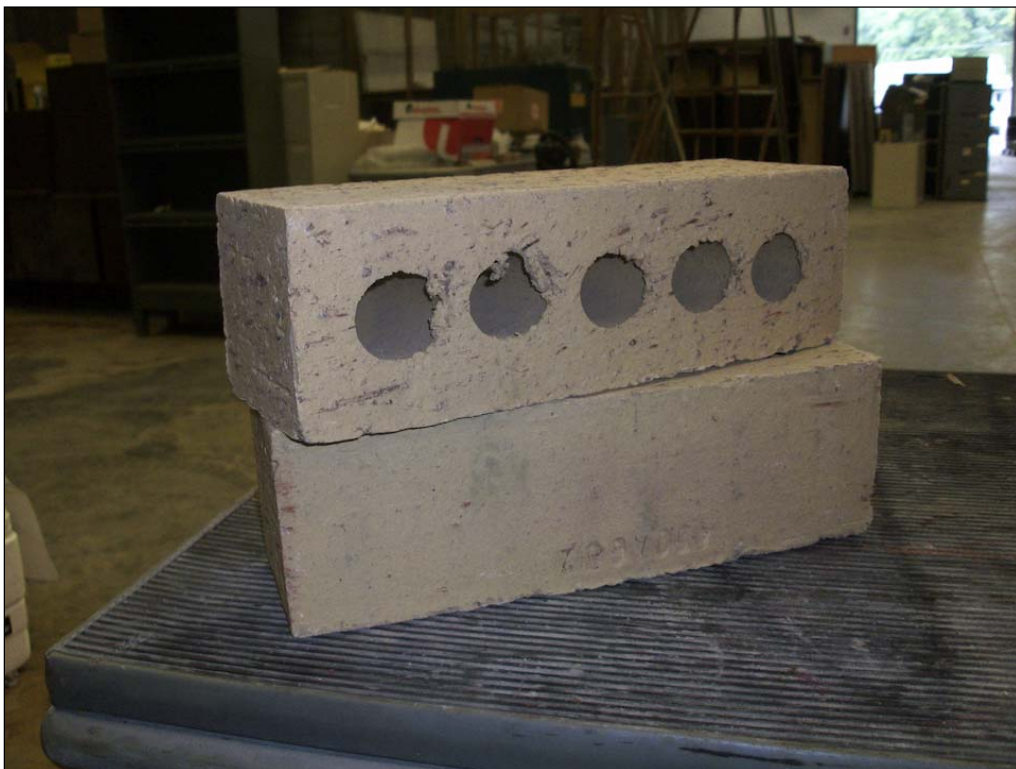
Figure 8. Utility brick.

The utility brick types are commonly used for commercial buildings because their larger size allows for a more efficient laying practice (Figure 8). The reclaimed bricks were gathered from an old burned building in Chicago (Figure 9). Reclaimed bricks are not as durable as other face bricks because of their worn edges and irregular shapes.

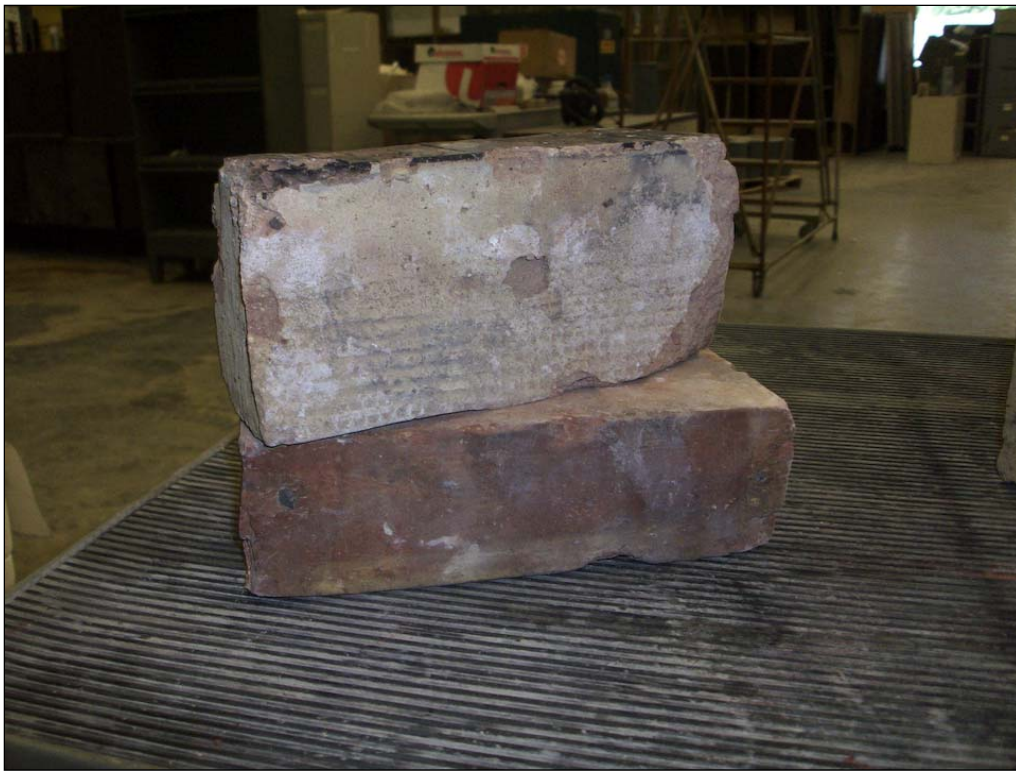
Figure 9. Reclaimed brick.

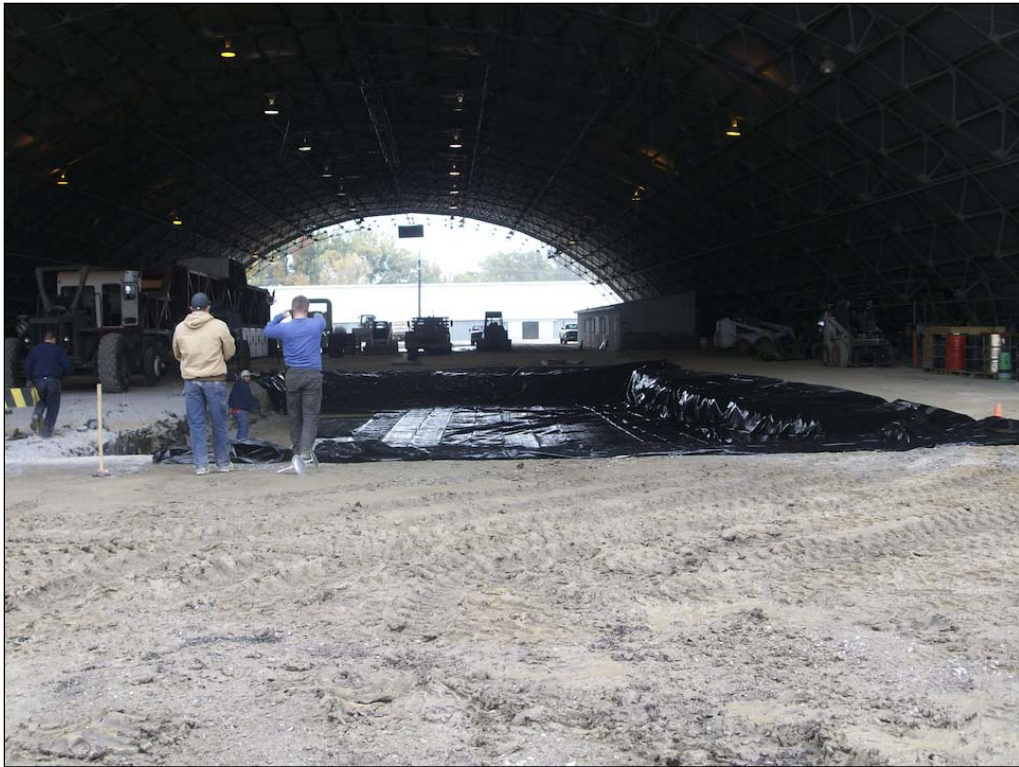
Figure 13. Test pit lined with polyethylene tarp for retaining moisture.

Construction began by excavating a 36-ft-wide by 80-ft-long by approximately 3.5-ft-deep test pit. The bottom of the pit was leveled and compacted. The test pit then was lined with an impermeable 6-mil polyethylene tarp to help retain the moisture in the constructed layers of the test section (Figure 13). The following sections describe the procedures used for constructing each layer of underlying material in the test section.

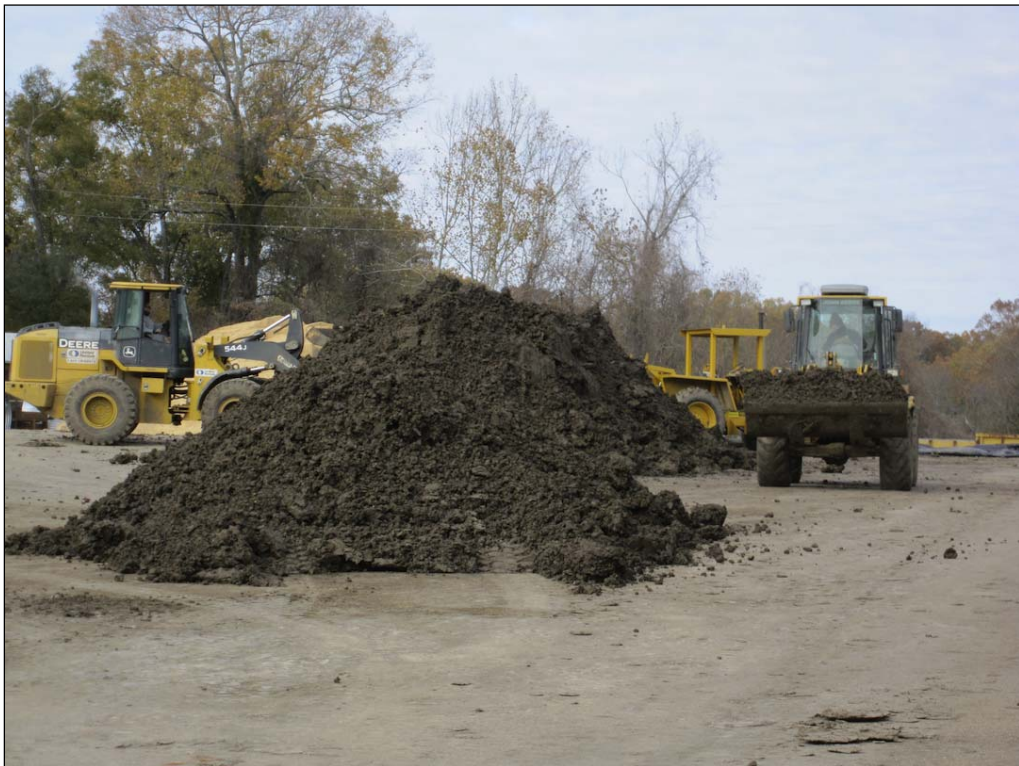
Figure 14. Processing CH material for subgrade.

The subgrade material consisted of approximately 2 ft of high-plasticity CH. This material was used because it is locally available and has a relatively good affinity for retaining moisture. The material was processed outside the test pit so that the moisture content could be adjusted to the desired level (Figure 14). The processing included spreading the material to a uniform 12-in. depth at a nearby preparatory site, mixing the material with a rotary mixer, adjusting the moisture content of the material, mixing the CH again, and stockpiling the soil. Once the optimum moisture content was achieved (approximately 34 percent), the CH was placed in the test pit in four separate 6- to 8-in. lifts. A rubber tire roller was used to compact each lift to approximately 6 in. for a total thickness of about 2 ft. Figure 15 shows a motor grader leveling the subgrade.

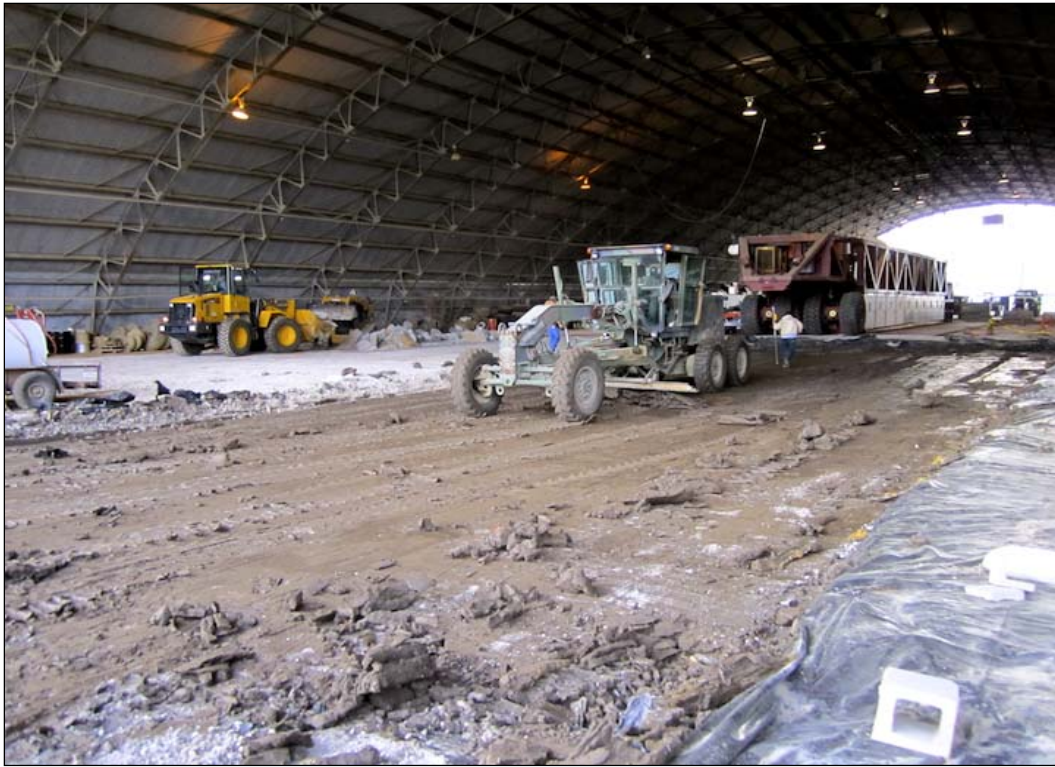
Figure 15. Motor grader being used to level subgrade.

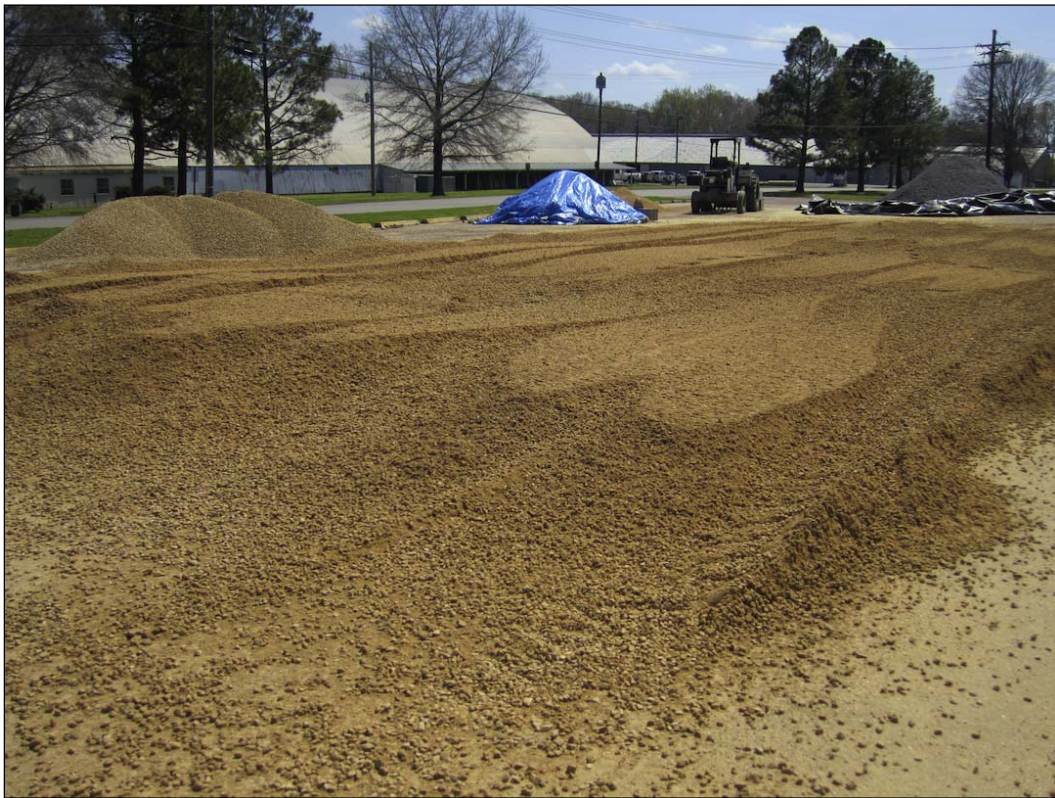
Figure 16. GM base course material drying to optimum moisture content.

The base course, classified as a GM material, consisted of a blend of two sizes of gravel (30 percent each), silt (5 percent), and sand (35 percent). The blend was created by moving the appropriate amounts of each material into a stockpile and mixing them with a front-end loader. The blend then was spread to a uniform 12-in. depth at a nearby preparatory site where it was mixed with a rotary mixer and allowed to dry to the appropriate moisture content (Figure 16).

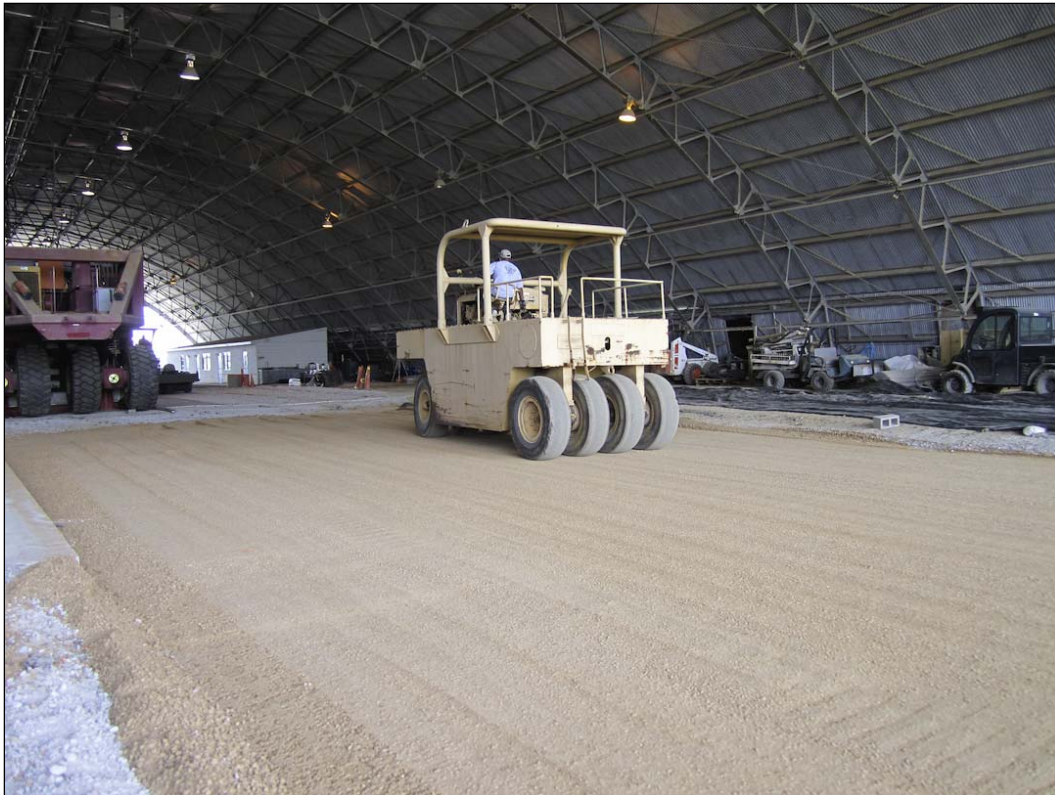
Figure 17. Rubber tire roller compacting GM base course material.

Once the optimum moisture content was achieved, the GM was placed on top of the compacted subgrade in two uncompacted 8-in. lifts. Each lift was compacted to approximately 6 in. using steel wheel and rubber tire rollers. Figure 17 shows a rubber tire roller compacting the base course. Each compacted lift was subjected to nuclear density, nuclear moisture, oven moisture, and CBR testing, and the results are presented in Table 10. The elevation and uniform grade of the base material were verified by center-line and cross-section profile readings.

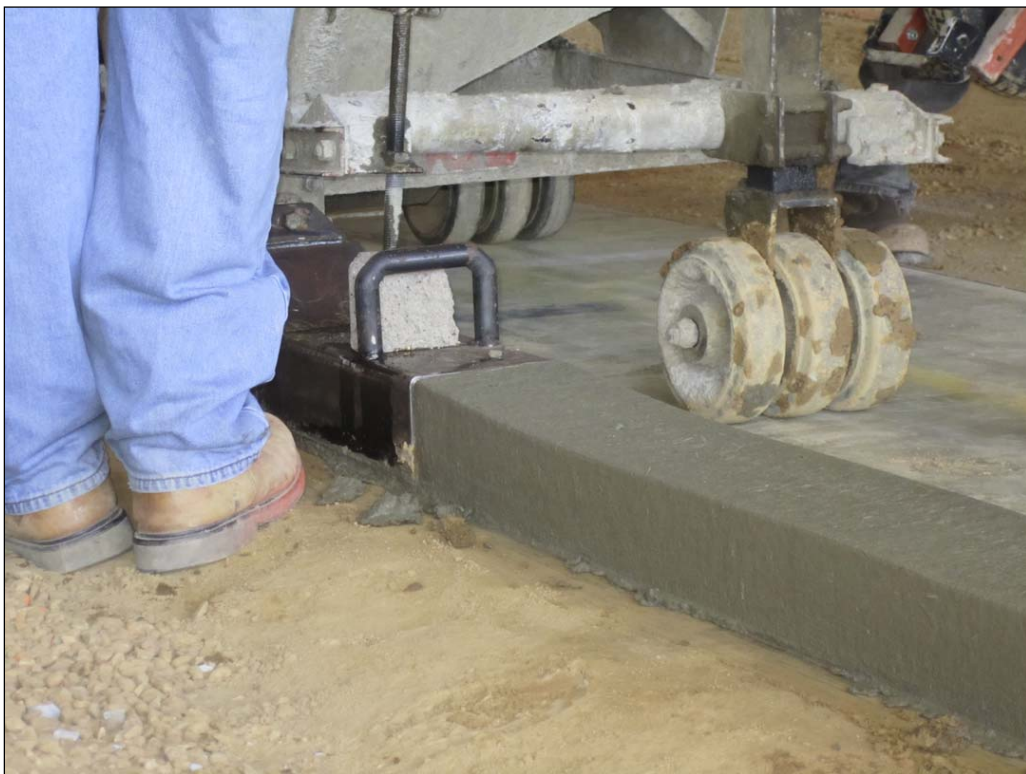
Figure 19. Installing concrete curbing.

A 4-in.-wide concrete edge restraint was added to the perimeter of the test section and between each lane to aid in keeping the bricks stable during construction and trafficking. The curbing was constructed with a machine that continuously poured concrete through a steel mold. The concrete had essentially zero slump because of the great number of fibers in the mixture. This was important to assure that the curb stayed in its desired form during placement. The concrete curb was constructed after the base course layer was completed. Figures 18 and 19 show the installation of the curb.

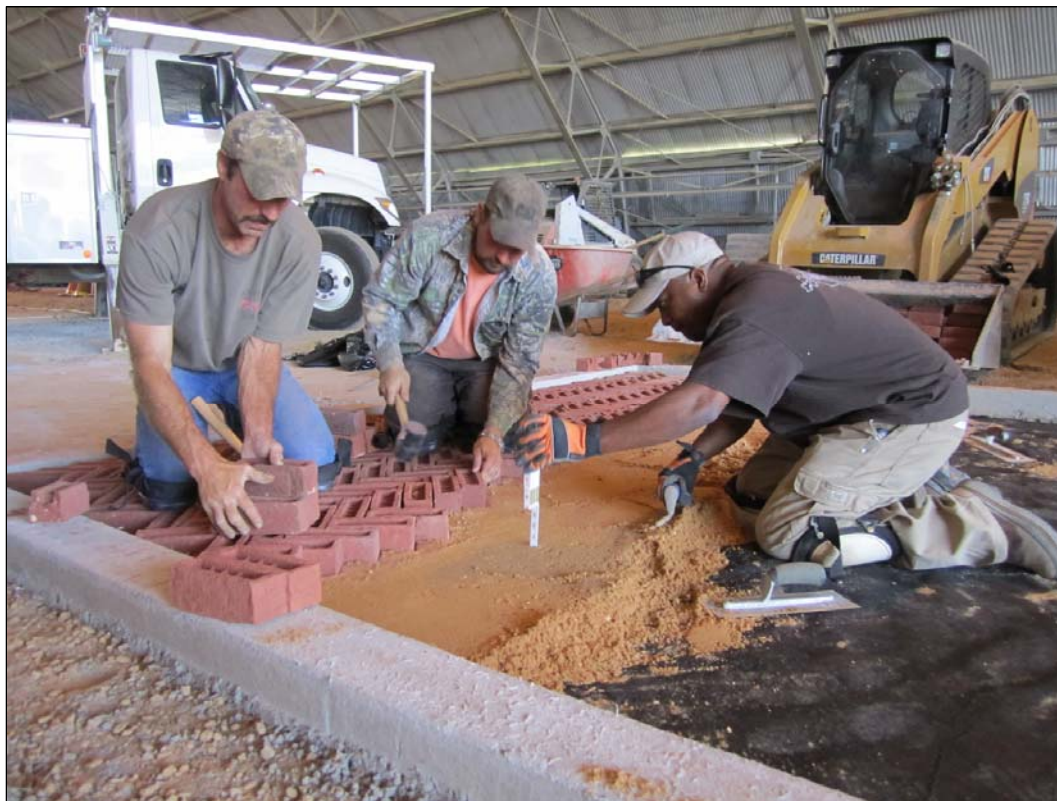
Figure 20. Installing queen bricks and measuring and spreading bedding sand.

The bricks were laid by hand on top of the bedding sand in a herringbone pattern (45-deg angles to each other) between the concrete curbing. The bricks initially were tapped into place using a rubber mallet. After the bricks were in place, a vibrating plate compactor was used to compact the bricks into the bedding sand. Sand was then swept into the joints of the bricks for adhesion and stability. A vibrating plate compactor was used again to help compact the sand in the joints. The process was repeated until the joints were completely filled with compacted sand. Figures 20 through 25 summarize the brick installation process.

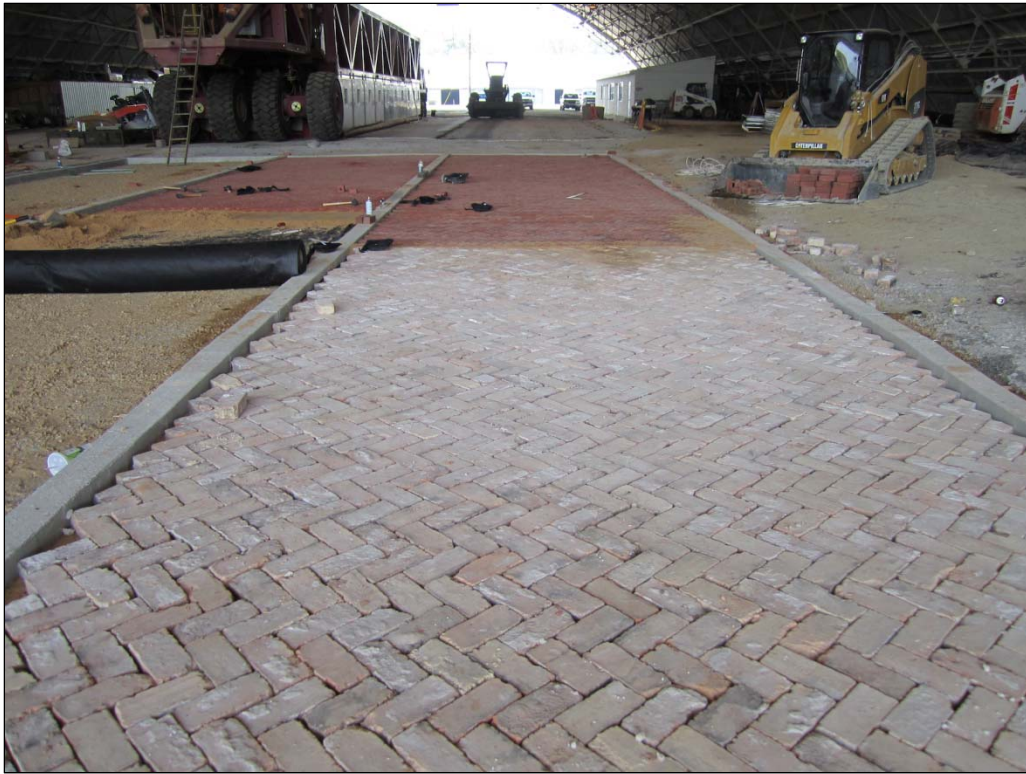
Figure 21. Partial brick test section before jointing sand.

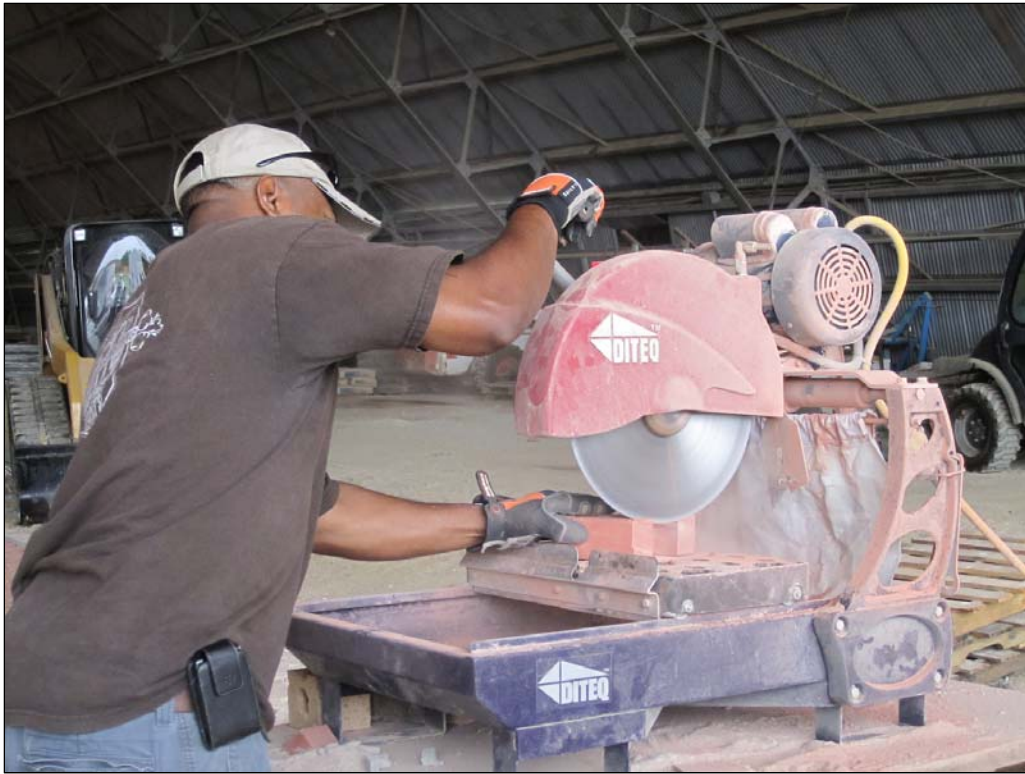
Figure 23. Sawing brick for installation at edges.

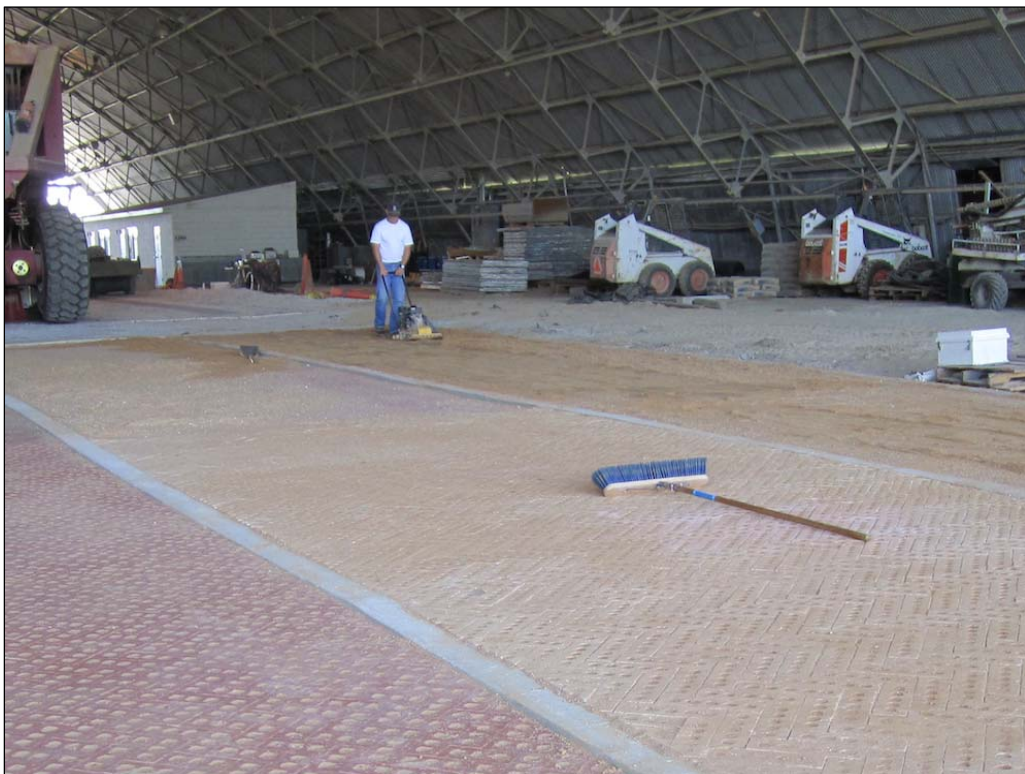
Figure 24. Using plate compactor to vibrate sand into joints.

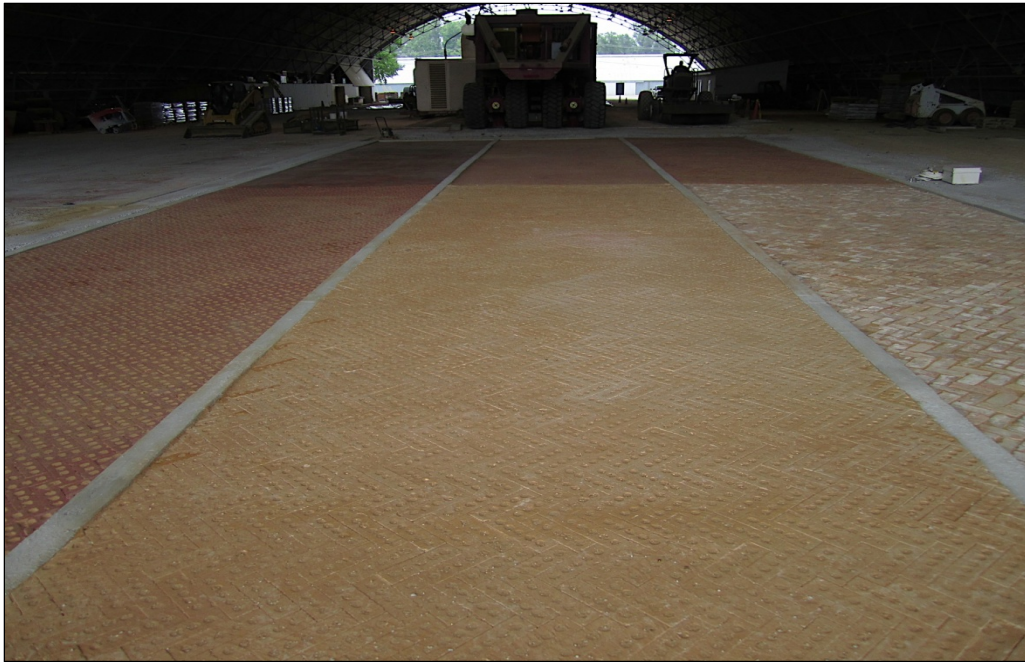
Figure 25. Completed test section.

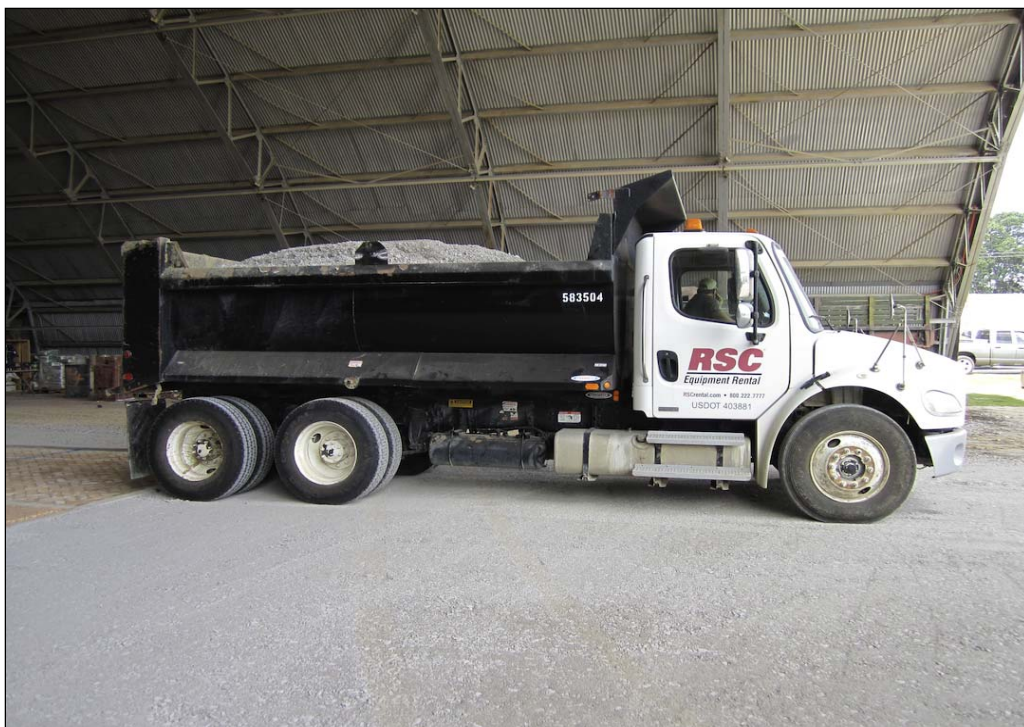
Figure 28. Loaded commercial dump truck.

The test section initially was trafficked in a channelized pattern using a dual-wheel, tandem-axle dump truck loaded to approximately 54,000 lb (Figure 28). Limestone was used to load the truck. The tire pressure of each wheel during trafficking was 109 psi. Trafficking was to conclude after 10,000 passes or when the test item failed. A flexible road pavement with truck traffic is considered failed when the brick surface layer has average surface rutting of 3 in.

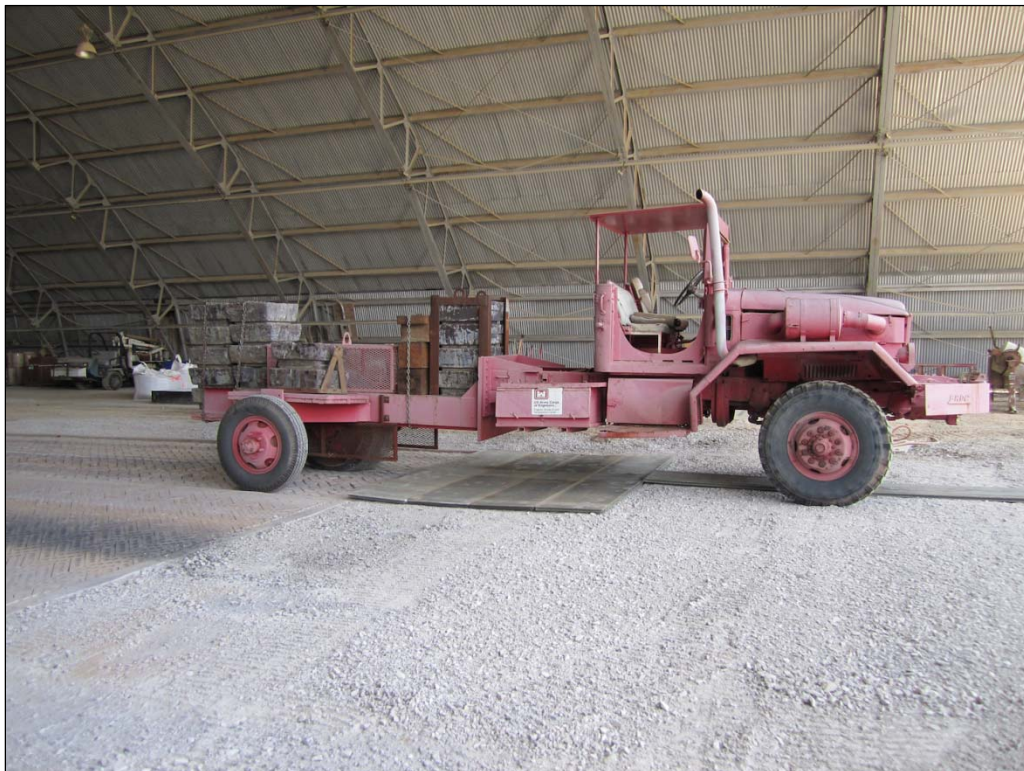
Figure 29. Single-wheel C-17 load cart.

approximately 42,000 lb and a tire pressure of 142 psi, was trafficked down the center of each item in a channelized pattern. Trafficking was to conclude at 1,000 passes or shortly after the test item failed. The failure criterion for military aircraft traffic on flexible pavements typically is based upon 1 in. of surface rutting. Figures 29 and 30 show the single-wheel C-17 load cart on the test section.

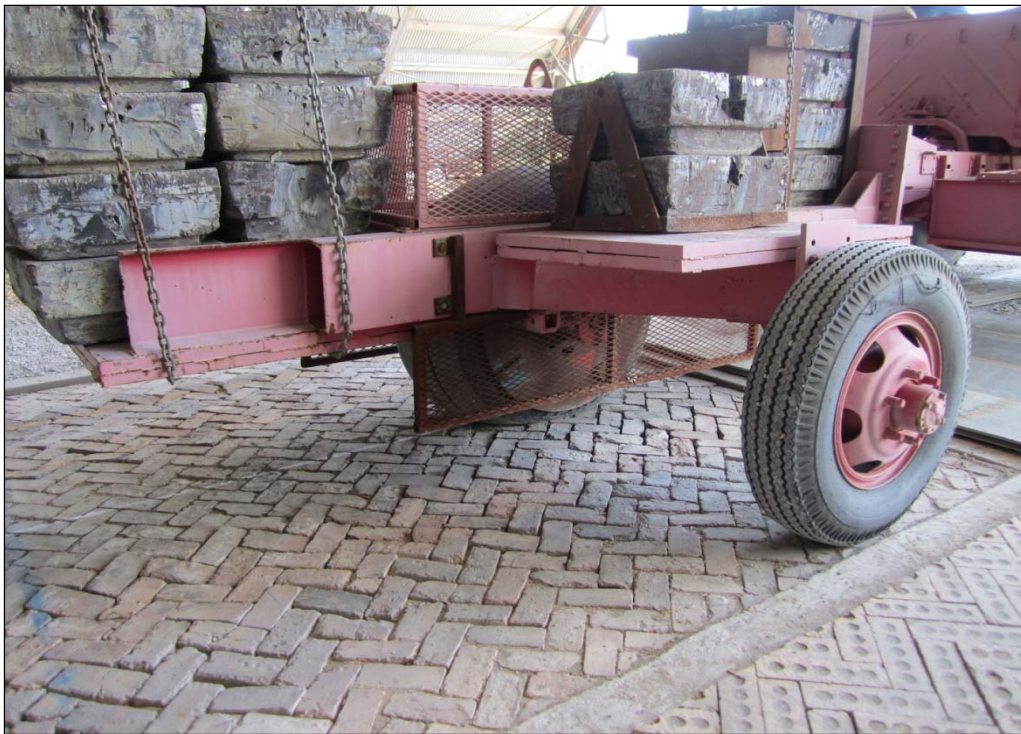
Figure 30. Single-wheel C-17 load cart on test section.

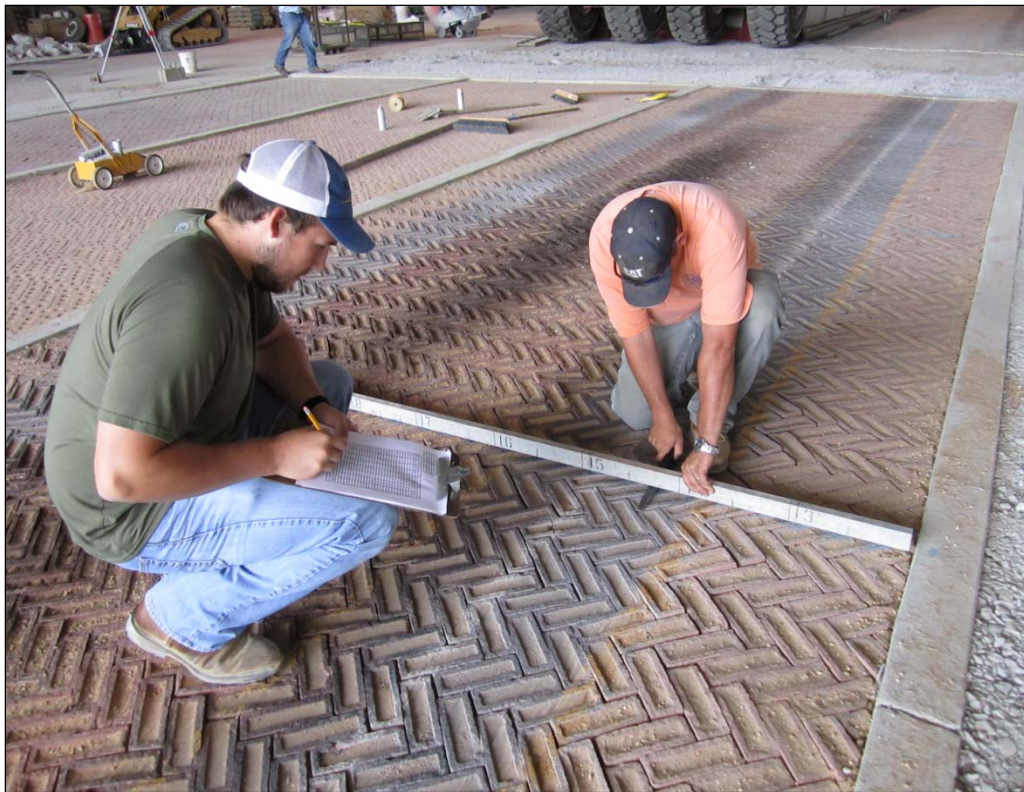
Figure 31. Rut depth measurements on Item 1.

For all traffic, the maximum total rut was recorded. The maximum total rut is defined as the elevation between the peak of the upheaval and the bottom of the ruts. Figure 31 shows a rut being measured in Item 1 after an interval of truck traffic.

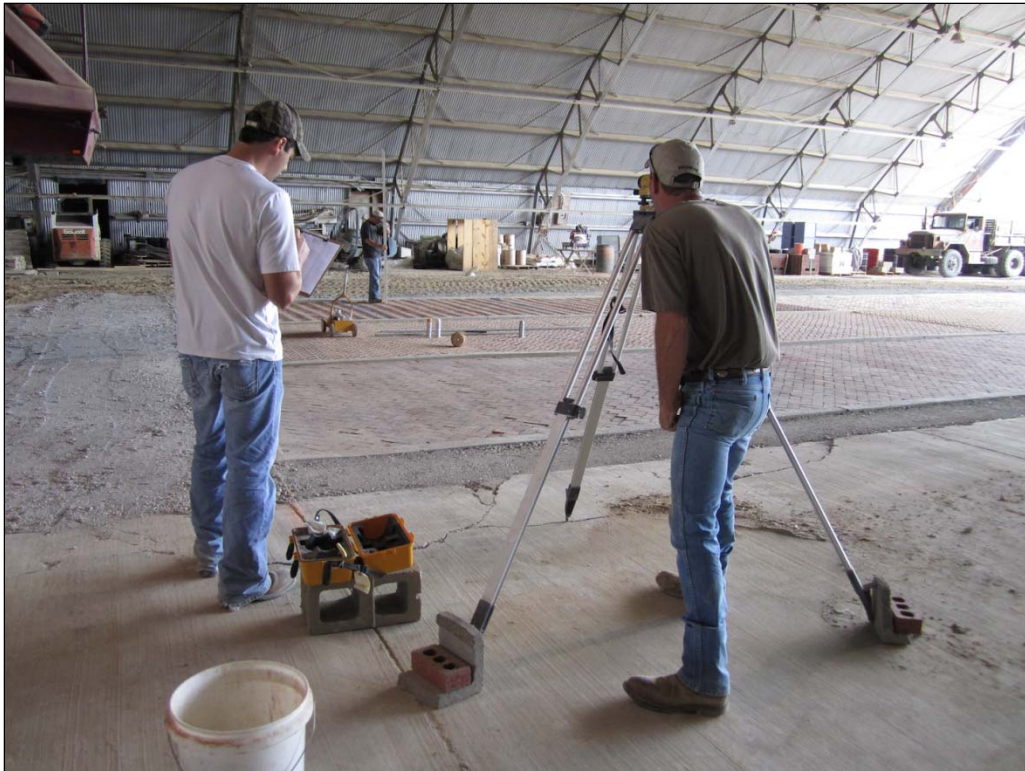
Figure 32. Longitudinal rod and level profile readings on Item 1.

and in the center of the wheel path for the C-17 traffic. Cross-section profiles were measured at each quarter point (Stations 10, 20, and 30). All measurements were recorded in 6-in. increments. The results were used to illustrate the permanent surface deformation in the wheel paths and across each item with an increase in pass level. Figure 32 shows longitudinal profiles being measured in the left wheel path of Item 1 after an interval of truck traffic.

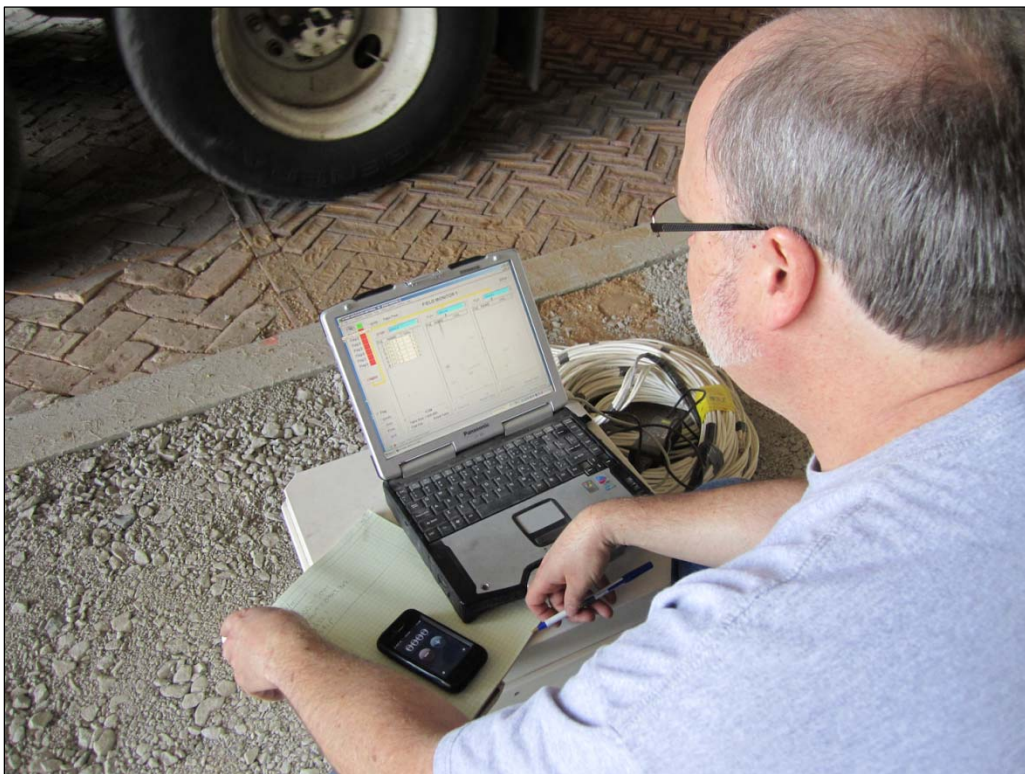
Figure 33. Collecting instrumentation measurements during truck traffic.

The instrumentation data, consisting of pressure cell measurements, was collected using dynamic readings over each device or stack of devices. At the start of the traffic intervals, the instrumentation data were recorded for approximately ten passes to show the response as the wheel moved toward and away from each device (Figure 33). Instrumentation data were not collected during C-17 trafficking.

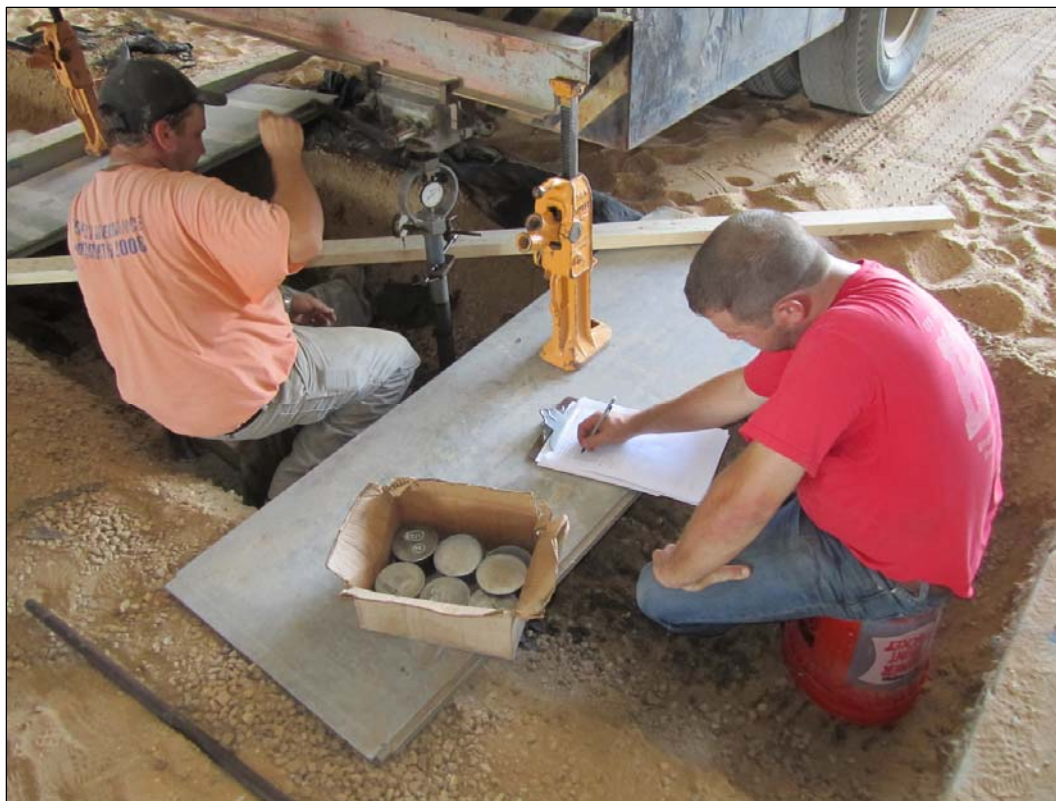
Figure 34. Subgrade CBR testing in trenched test item.

After all trafficking of the test section was completed, a 3-ft-wide trench was excavated across the center (Station 20) of each test item for forensic investigation. Each layer of the pavement structure at the center of the C-17 wheel path rut and in areas outside of the rut was removed and assessed. DCP tests, CBR tests, and oven moisture tests were completed at each location on each foundation layer (Figure 34). Furthermore, rod and level cross-section profile measurements (6-in. increments) were performed on the surface of each layer to aid in determining where failure occurred.

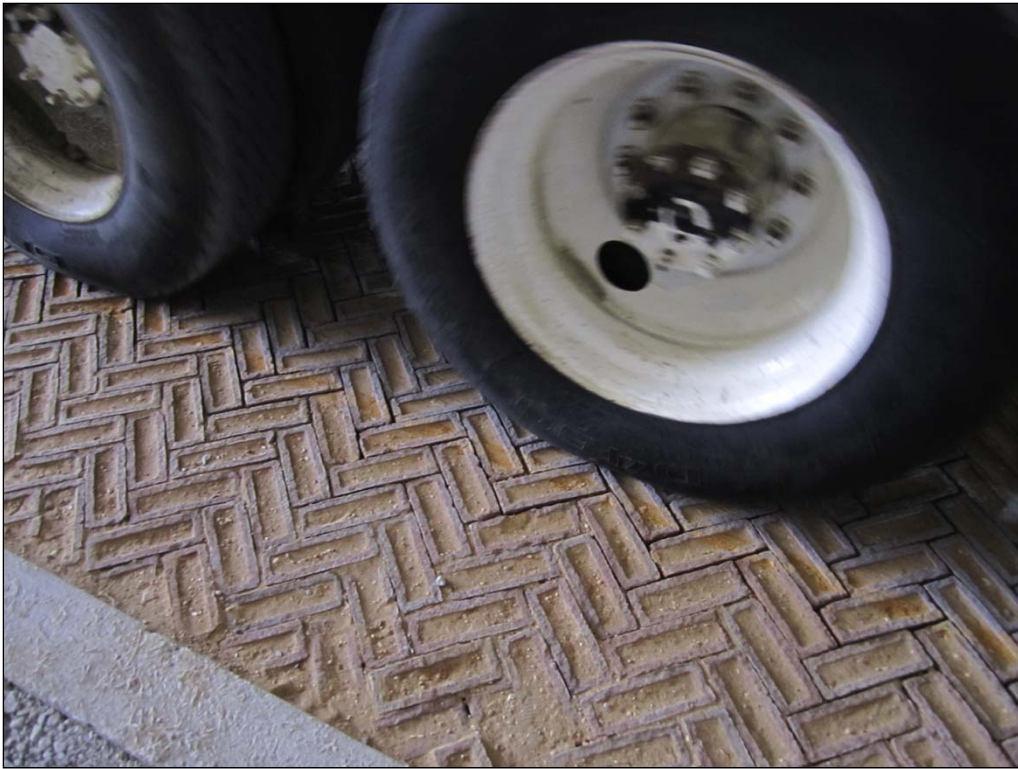
Figure 35. Item 1 truck traffic at approximately 200 passes.

Item 1 was trafficked to 10,010 passes without failure. The queen bricks showed loss or settlement of sand between the bricks in the wheel paths after 10 passes. Figure 35 shows voids with missing sand between the bricks inside the wheel path at around 200 passes and compacted sand between the bricks outside of the wheel path. The bricks remained relatively flat throughout trafficking. There was little movement and little to no breaking of the queen bricks with the truck traffic.

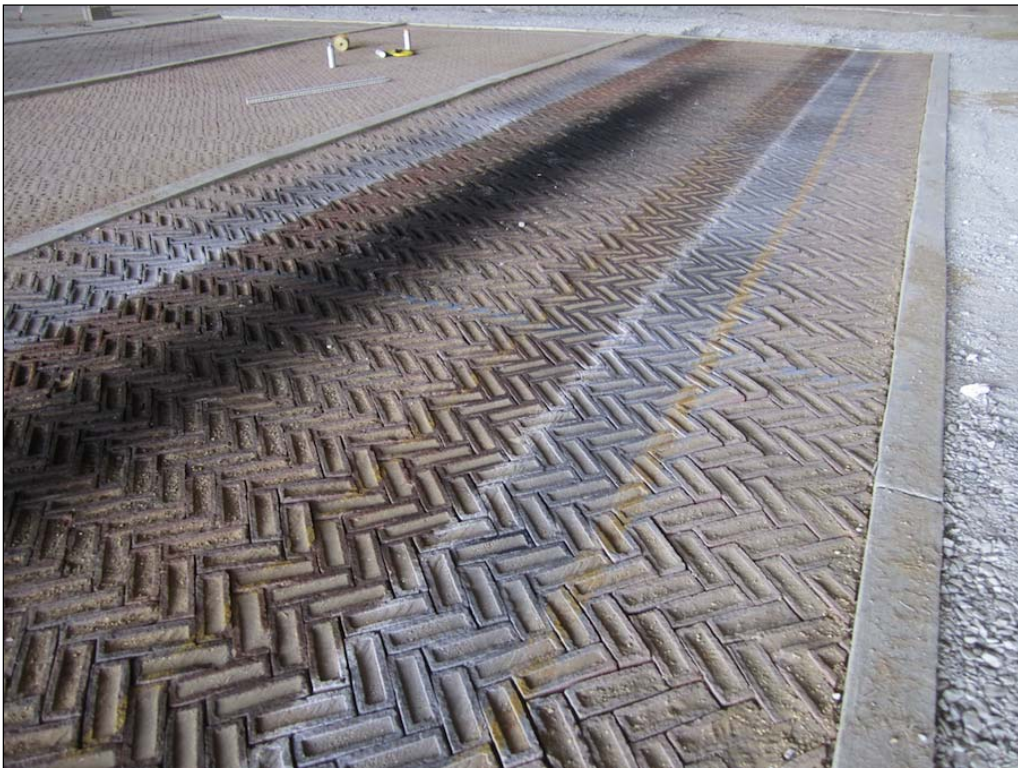
Figure 36. Item 1 at completion of 10,010 passes of truck traffic.

The satisfactory performance of the queen bricks was surprising. The queen bricks had an average laboratory compressive strength of approximately 4,800 psi and an approximately 55 percent loss of material when they underwent the LAA test. Figure 36 shows Item 1 at the completion of 10,010 passes of truck traffic.
